Draft Final Preliminary Design Plan

Clark Fork River Operable Unit Phases 15 and 16

Grant-Kohrs Ranch National Historic Site

#114-560435
January 31, 2015

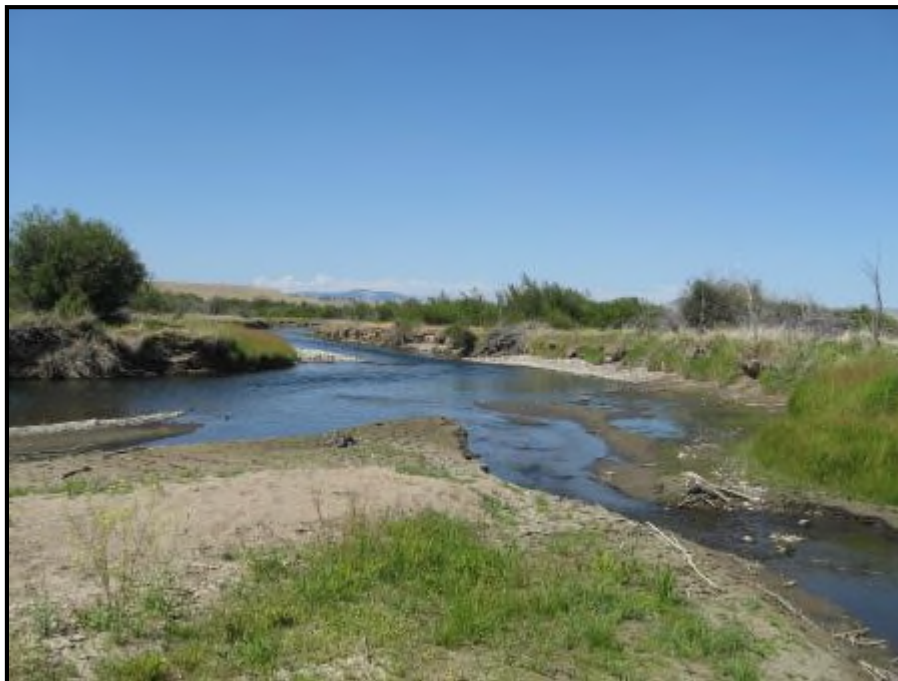
Figure 2-1. View downstream (Station 90+00) Showing Entrenched Cross Section

Within Phases 15 and 16 through GKR, the CFR is a single thread meandering stream that is largely entrenched below at least the 2-year water surface elevation (Figure 2-1). Phase 15 is approximately 1.2 river miles long, and Phase 16 is 1.4 river miles long. The riverbed consists primarily of well-sorted gravels and cobbles that support the formation of discreet riffles, pools and long run features. Bank erosion is concentrated on demonstrably migrating cutbanks on meander bends. These cutbanks are commonly associated with lateral scour pools, and the deepest pools tend to form against relatively slowly migrating cutbanks. In general, the channel is a C3/C4 channel type (Rosgen, 1996), with a gravel/cobble bed, width to depth ratios on the order of 28 at the 2-year event, a 0.2 percent slope, and moderate sinuosity. Table 2-1 contains a summary of basic planform and pool inventory data.

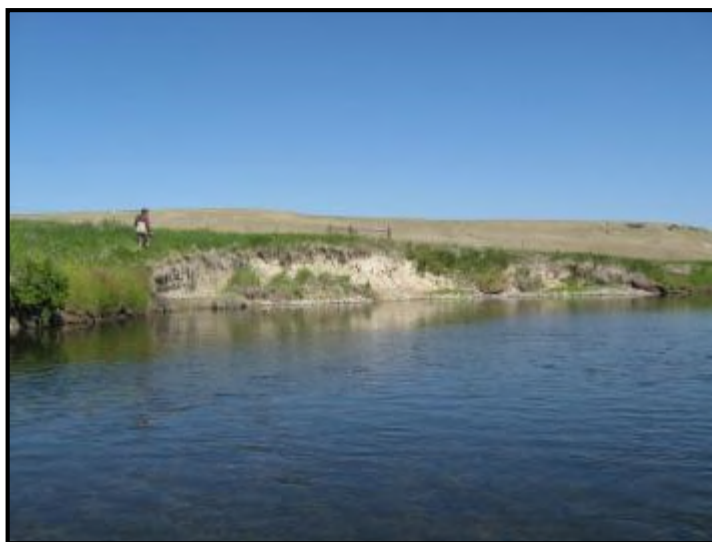
Figure 2-2. View Downstream (Station 66+00) Showing High Uncontaminated Bank

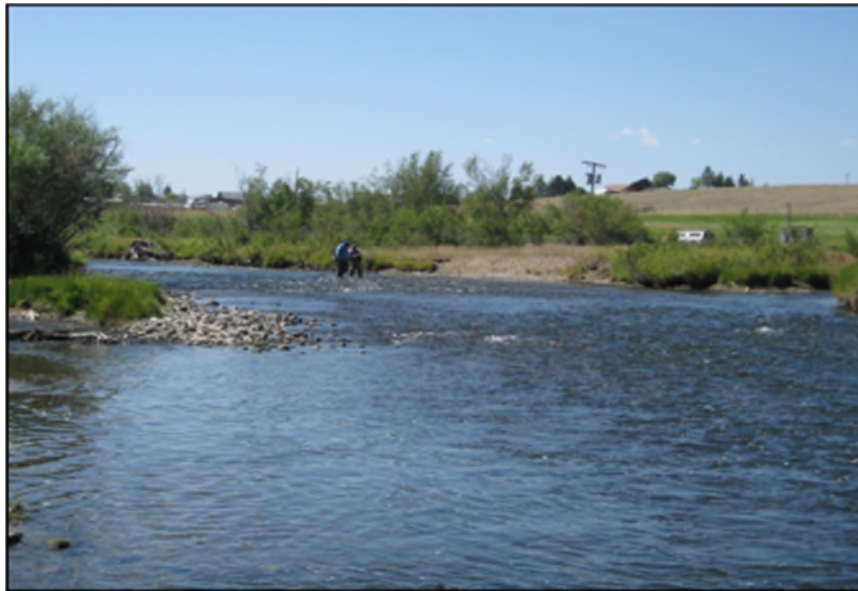
Figure 2-7. View Upstream from Station 130+00 Showing Coarse Riffle Feature

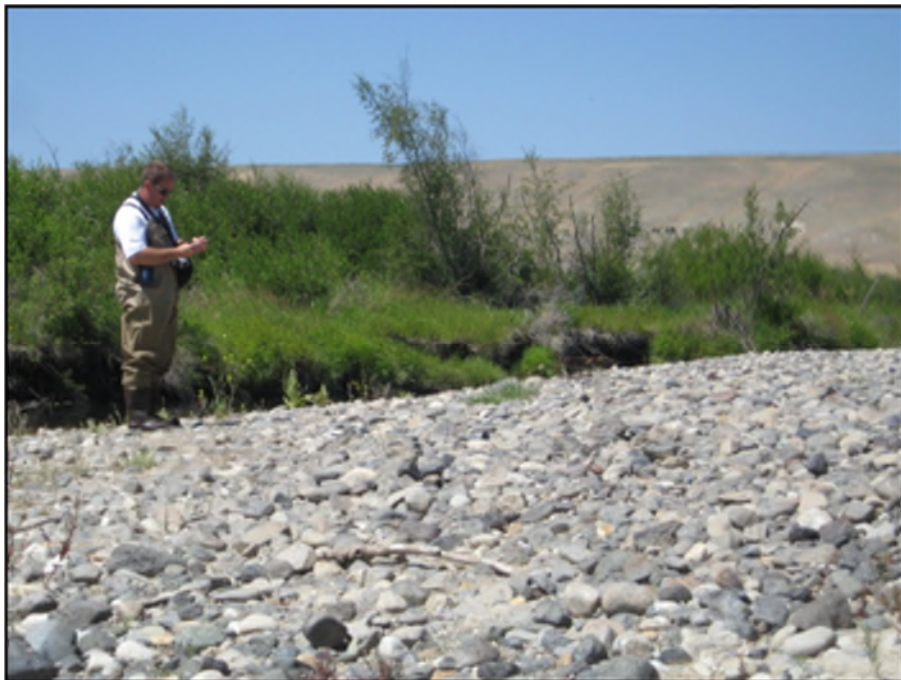
Figure 2-11. View Downstream of Coarse- Grained, Recent Bar Deposit, Station 108+00

Active sediment transport of coarse bedload in the reach is evidenced by the presence of coarse-grained, unvegetated, high elevation point bars (Figure 2-11) as well as in-stream migrating bedload features with convex downstream margins that form steep progradational wedges (Figure 2-10). The presence of these materials, coupled with measurable migration of cutbanks between 2009 and 2011 suggests that high flows in 2010 and 2011 effectively mobilized the coarse bedload. Swanson (2002) concluded that most bank erosion and sediment transport in this reach occurs at flows greater than 1,100 cfs. The 2010 peak (1,540 cfs) was between a 2- and 5- year event, whereas the 2011 peak (1,970 cfs) was between 5- and 10-year event. In 2011, the high flows were also of long duration; the 2-year discharge of 922 cfs was exceeded at the Deer Lodge gaging station for several weeks between mid-June and mid-July.

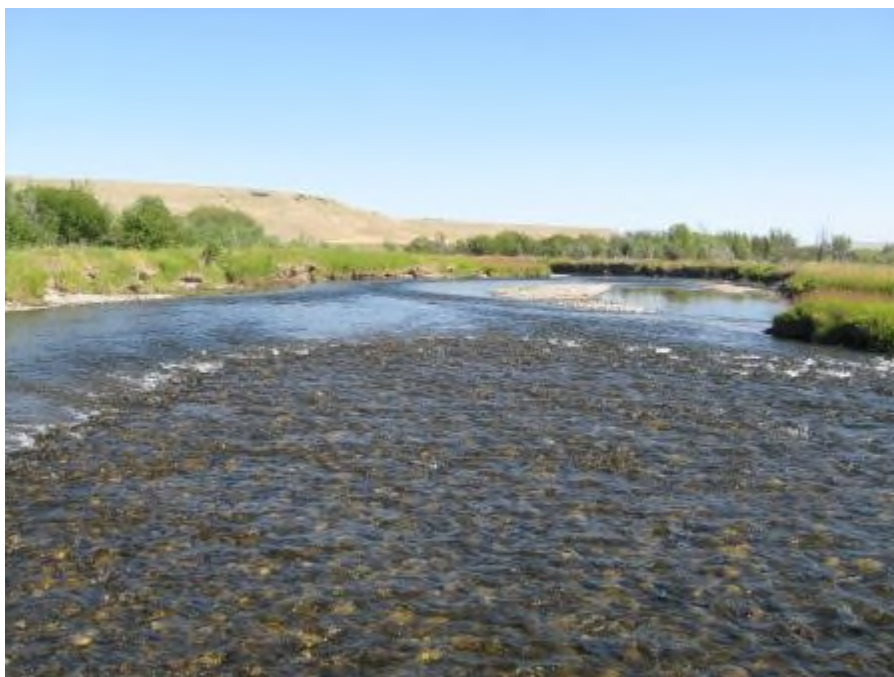
Figure 2-10. View Downstream of Large Prograding Gravel/Cobble Bedform, Station 72+00.

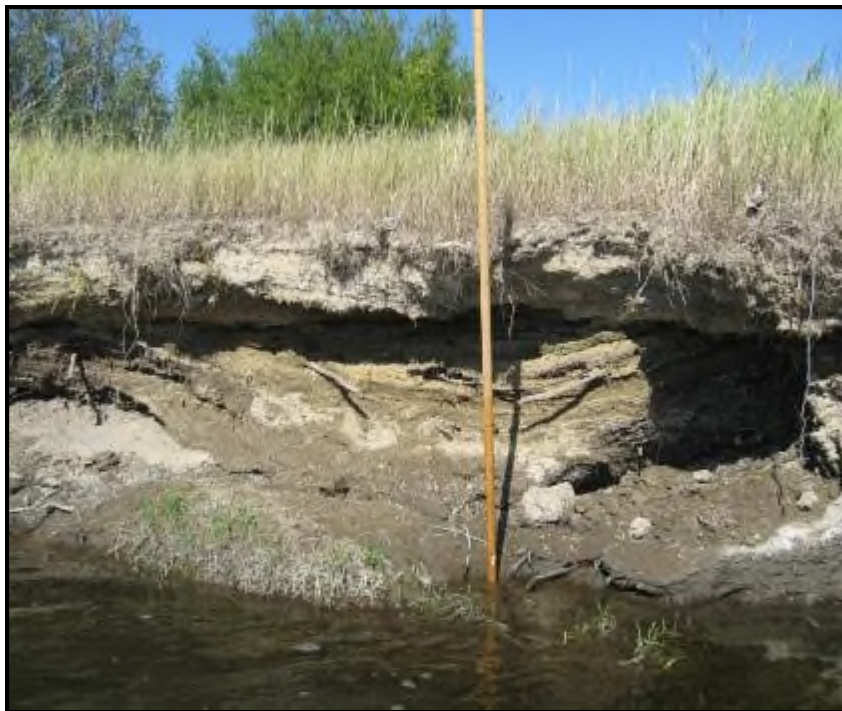
Figure 2-16. Tailings Deposition in an Old Channel, Station 84+00R

These historic accounts are corroborated by extensive tailings exposures in streambanks. In places, thick tailings deposits have filled relatively small historic channel features that are exposed in cross-section along the bankline (Figure 2-16). These exposures document a pre-1908 floodplain that supported multiple channel threads, which may have been associated with beaver activity. Tailings are also commonly laminated indicating multiple depositional events of reworked material (Figure 2-15). The most visible tailings are typically found in the upper third of the streambank, creating high banks and channel entrenchment over a native bank toe (Figure 2-17). At Station 94+00, approximately 2 feet of massive overlying organic rich material appears to exemplify the practice of dumping manure on banks as part of early reclamation efforts (Figure 2-18; Swanson, 2002). Bones found on bars and in banks show bright blue staining from the contaminants (Figure 2-19).

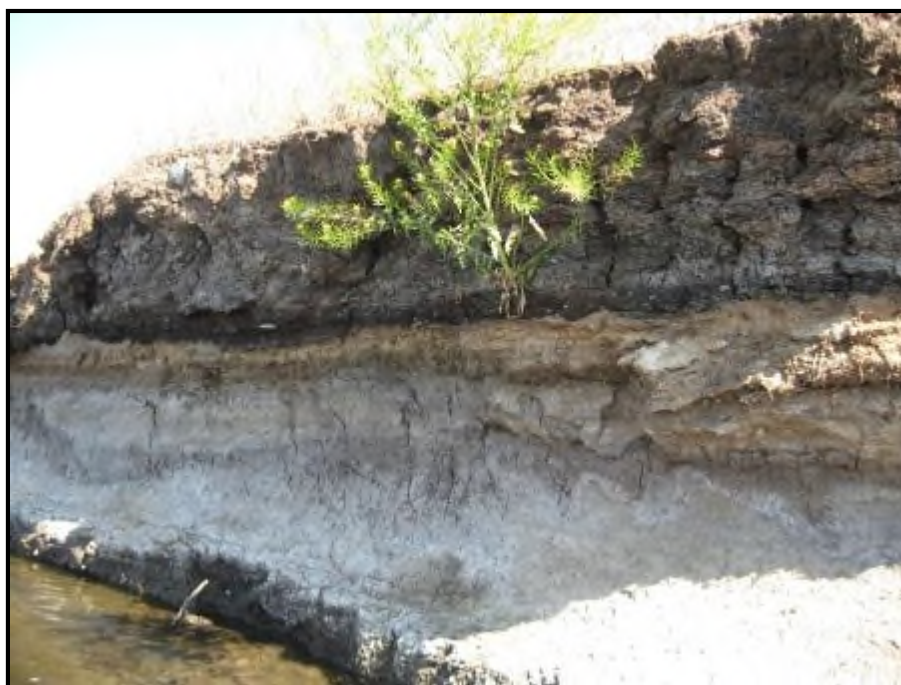
Figure 2-18. Tailings Under Manure-rich Fill, Station 94+00R

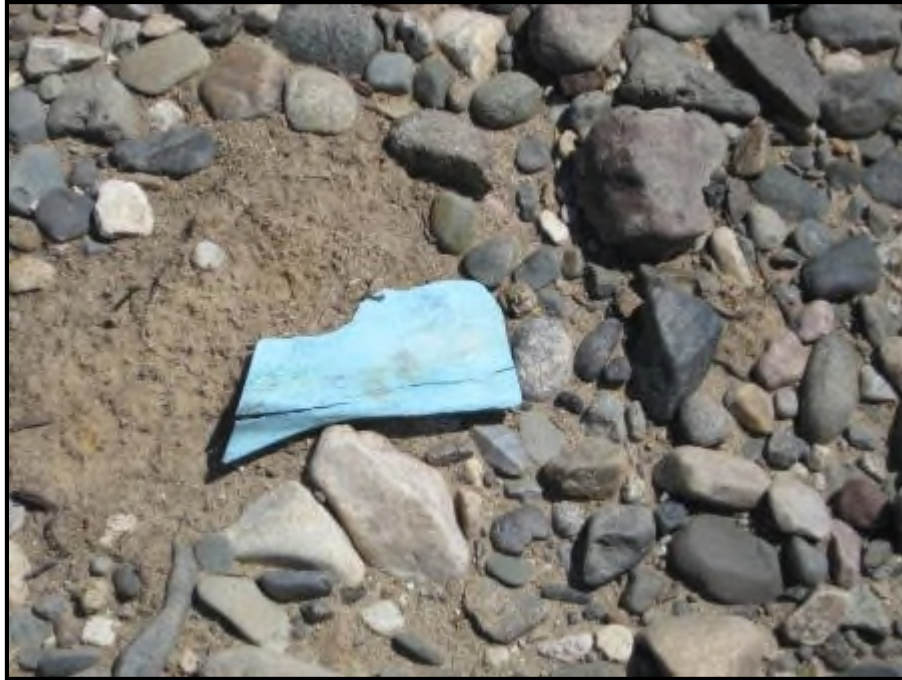
Figure 2-19. Blue-colored Bone on Bar Surface, Station 56+00L

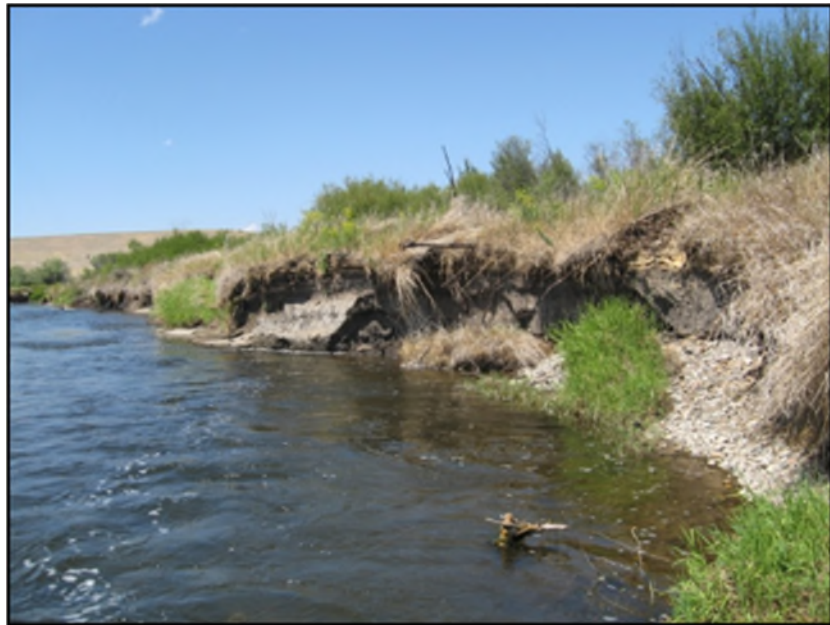
**Figure 3-2. View Downstream from Station 111+50R
Showing Variable Toe Materials**

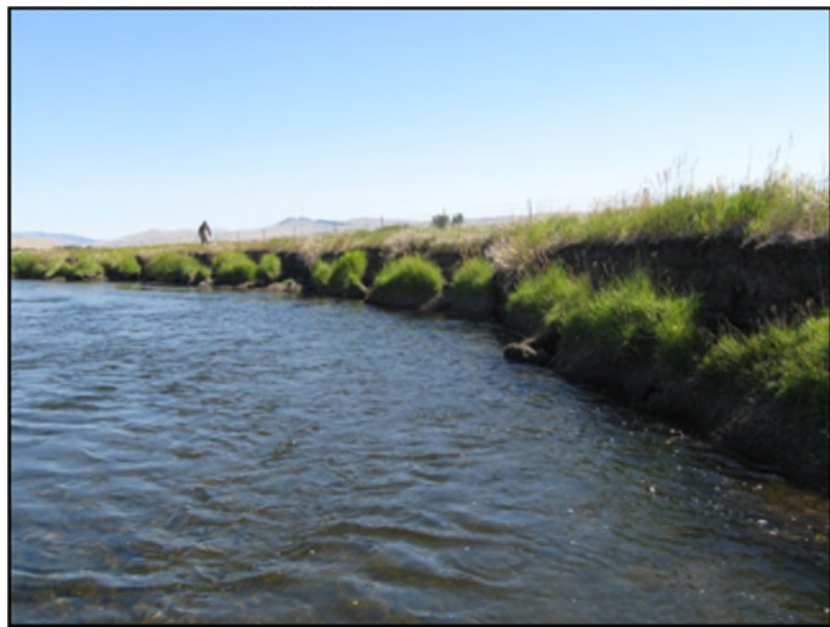
**Figure 3-3. View Downstream (Station 58+00) Showing
Bank Undercutting/Topple Failure**

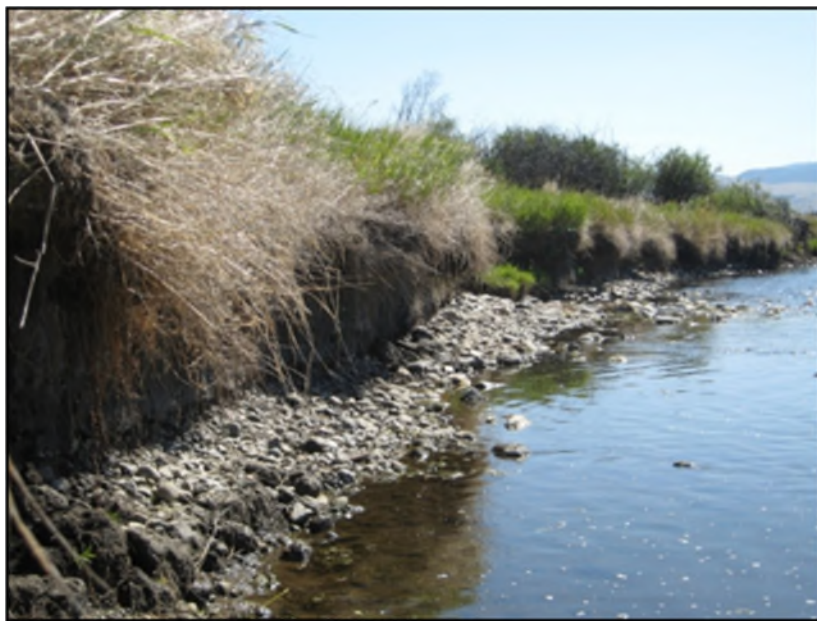
Figure 3-4. View Downstream at Station 62+00 Showing Coarse Bank Toe

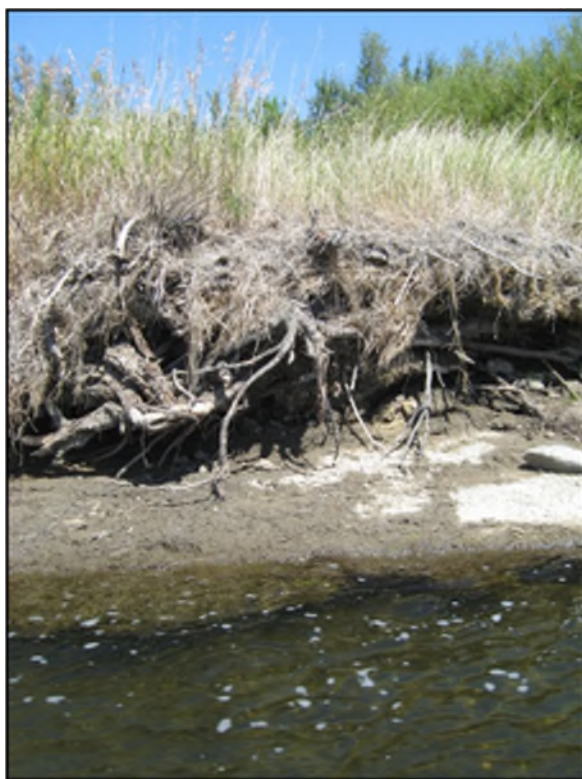
Figure 3-5. Typical Cohesive Bank Toe

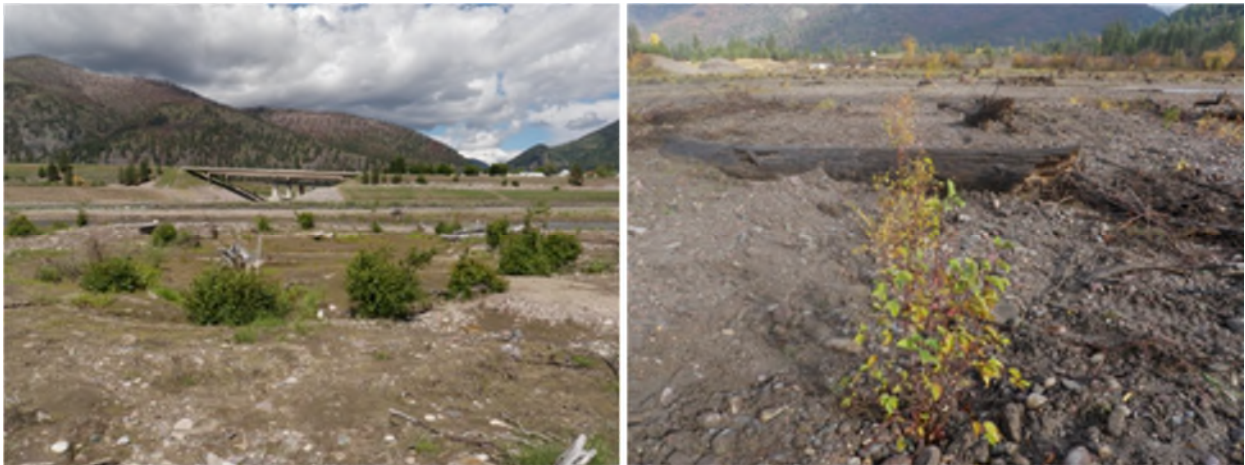
Figure 3-12. Examples of Constructed Floodplain Swale Features

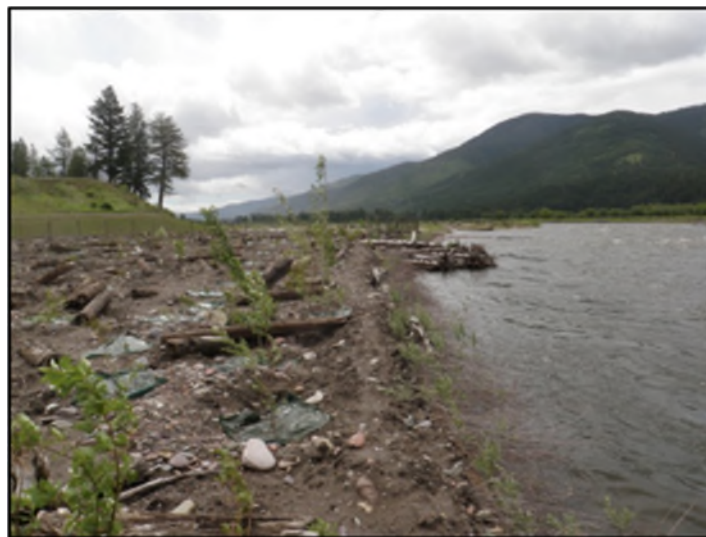
Figure 3-13. Microtopography Placed on a Constructed Floodplain Surface

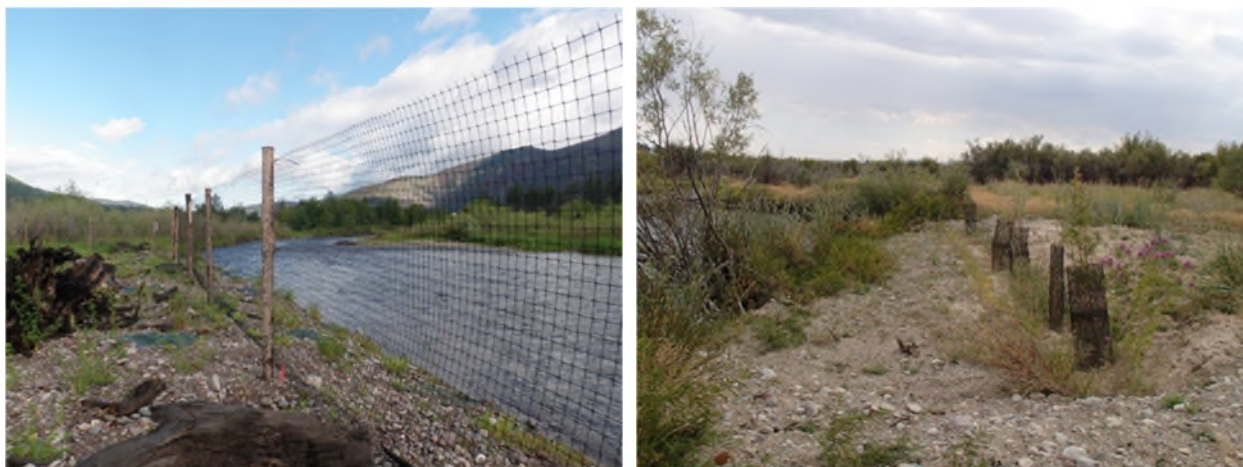
Figure 3-14. Examples of Browse Protection Measures: Wildlife Exclosure Fence (left) and Individual Browse Protectors (right).
